# Update: Sound to the Ground

Jason Bromirski

## Acoustic Inspection Design Concept

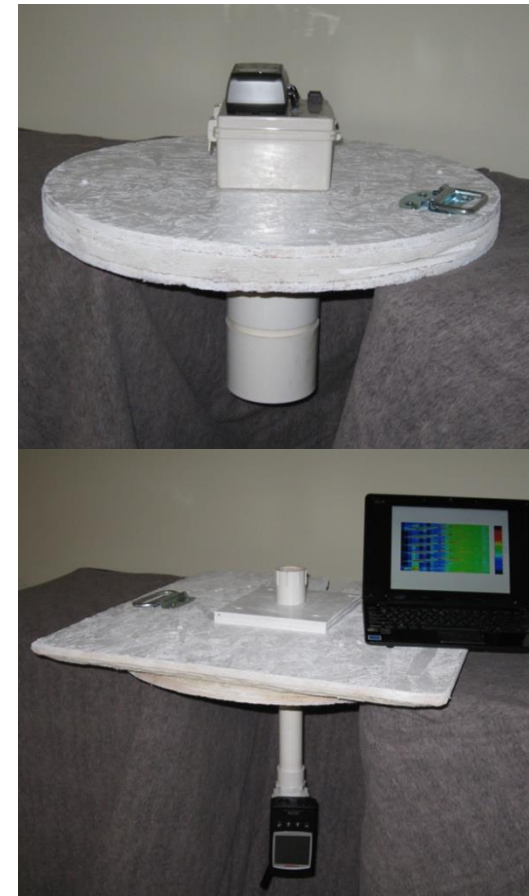
## Acoustic Inspection Design Concept

- Prototype circa 2007
- Audio Transmitter
  - Custom Speaker
  - Audio Amplifier
  - Sound Source
- Audio Receiver
  - Audio Spectrum Analyzer
  - Recorded to NetBook via USB Cable

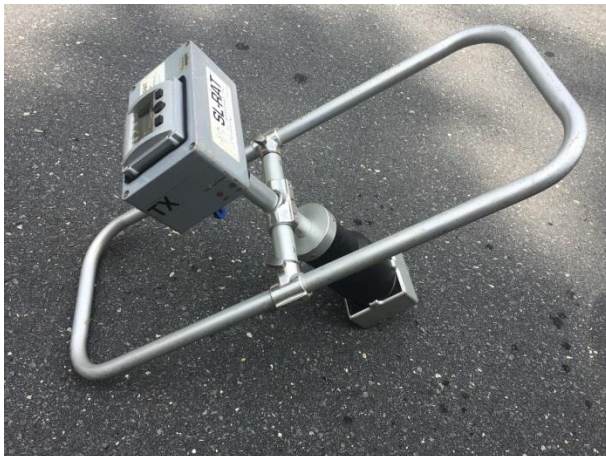
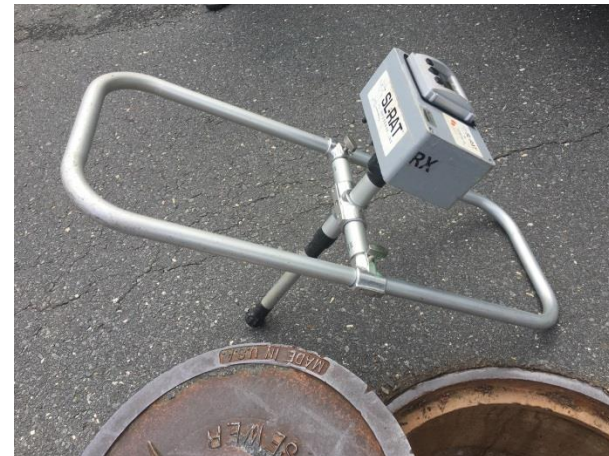
## Sewer Line Segment Assessment Process

- Assessment Time
  - Measurement <30s to 2min
  - Setup time - Variable

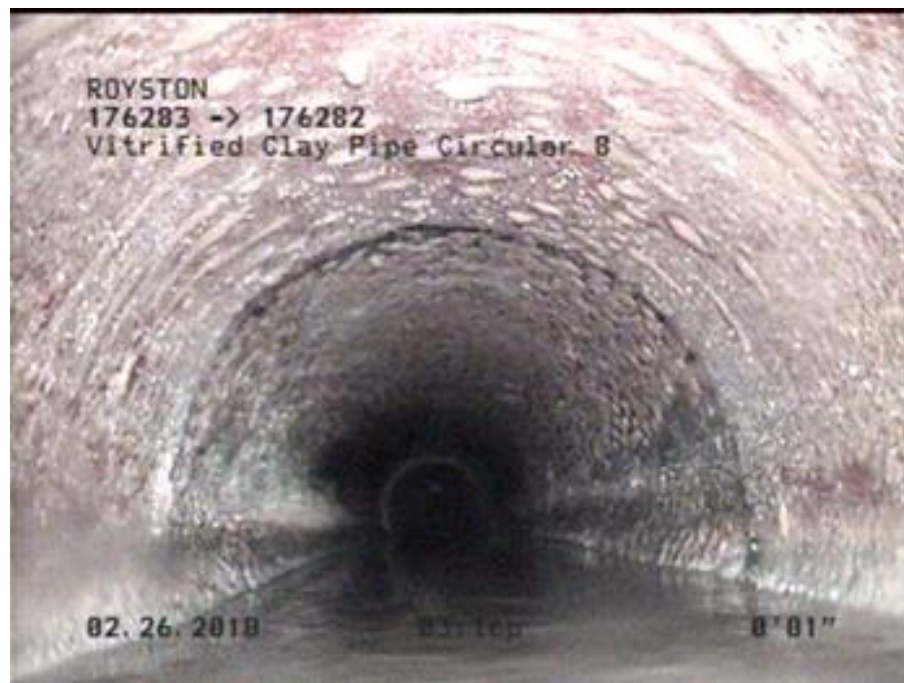
- CCTV Blockage Assessment – 7

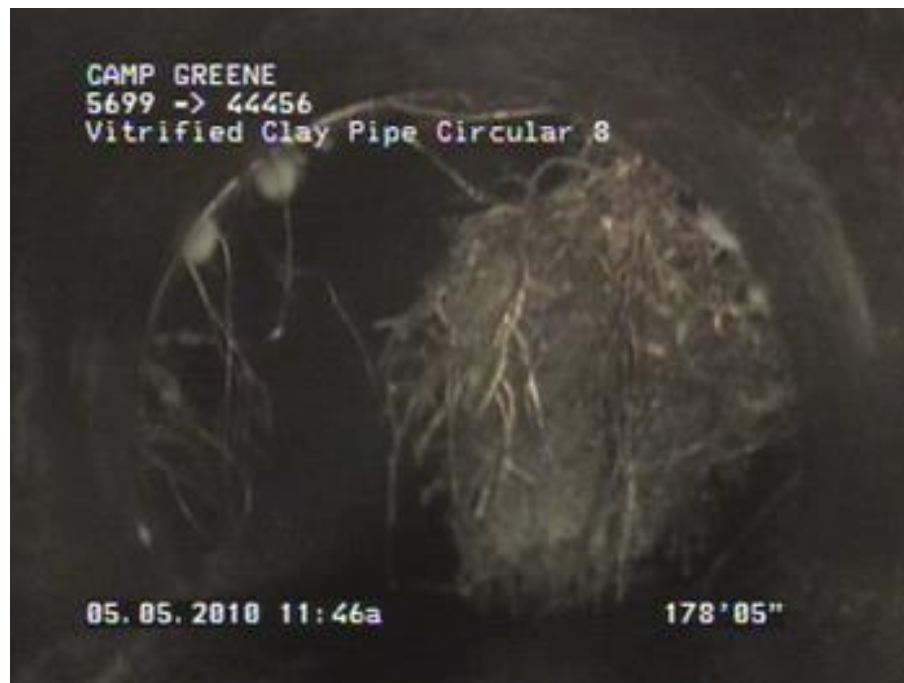
- CCTV Blockage Assessment – 5
- Camera able to travel through roots

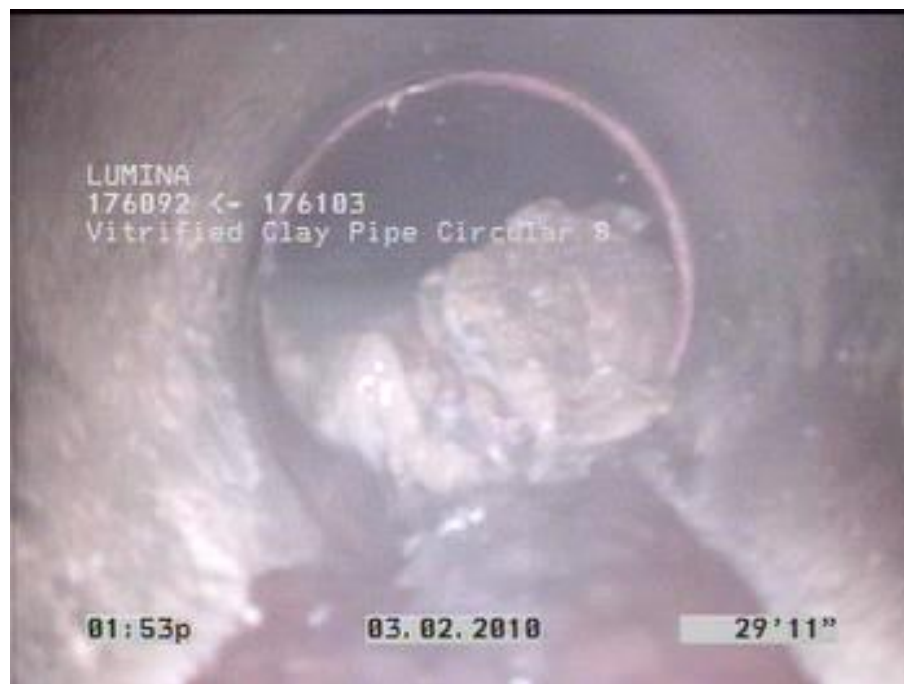
- CCTV Blockage Assessment – 2
- Camera unable to travel through blockage

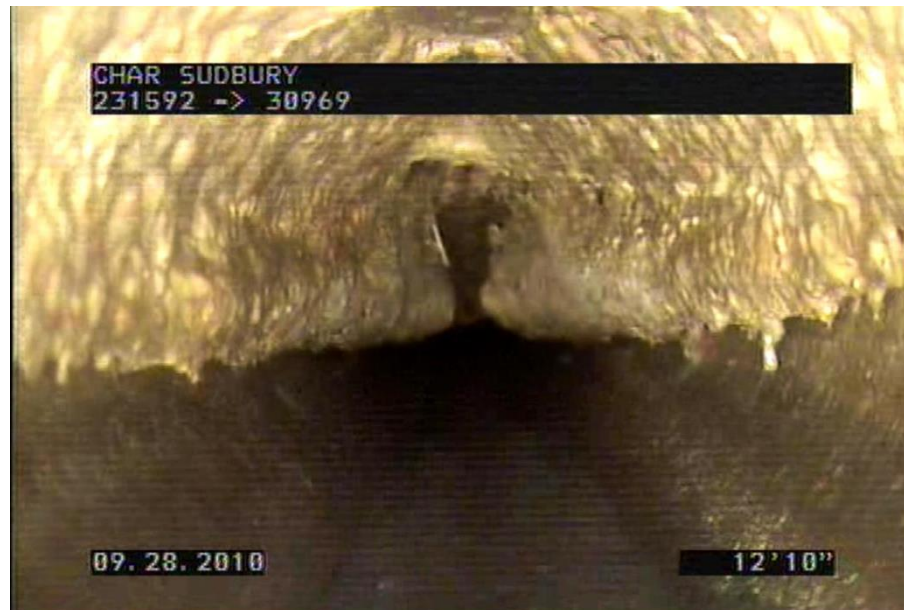
- CCTV Blockage Assessment – 0
- Complete blockage, impassable
